# CUTOFF WALL

## Abandoned Mine Tailings Pond

### Carcross, Yukon Territory

Case 7

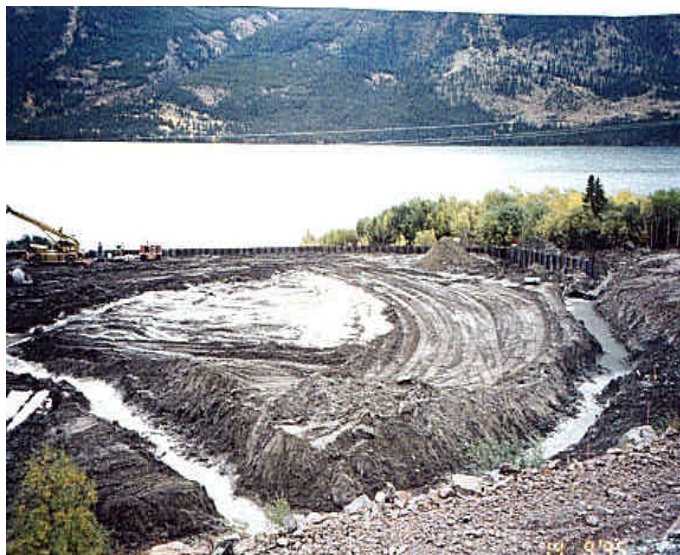
Figure 1, Site Overview

The site remediation plan was based on the installation of a vertical Waterloo Barrier® cutoff wall along the down gradient side of the former tailings pond to act as a barrier to prevent contaminated ground water from entering Bennett Lake. This barrier was to be placed as close as possible to the lake shore. Once the barrier was in place, a clay cap would be installed to prevent surface water from entering the pond and thus prevent further migration of contaminants into Bennett Lake. As shown in Figure 1, the tailings pond was bounded by the Highway on the up gradient side.

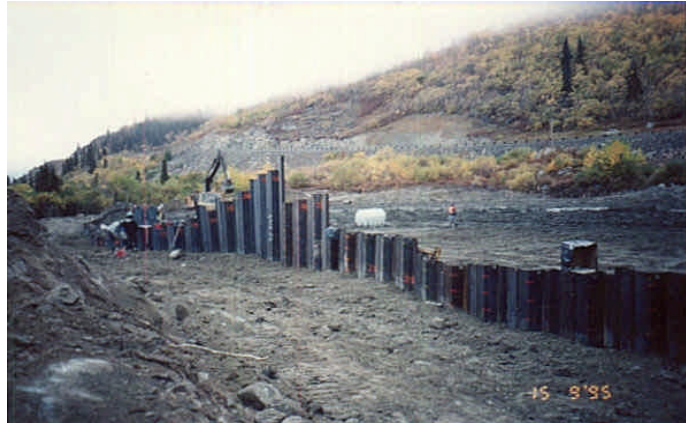
**Figure 2, Rock Outcropping**

Approximately 12,000 square feet of Waterloo Barrier® WZ75 sheet piling was installed, in varying depths (from 25 to 15 feet), following the bedrock profile along the down gradient side of the former tailings pond. As can be seen in Figure 2, the preparatory geotechnical work was very beneficial as only one unexpected rock outcropping was encountered. The sheet pile driving was completed using a 2,500 lb impact hammer and a mobile crane.

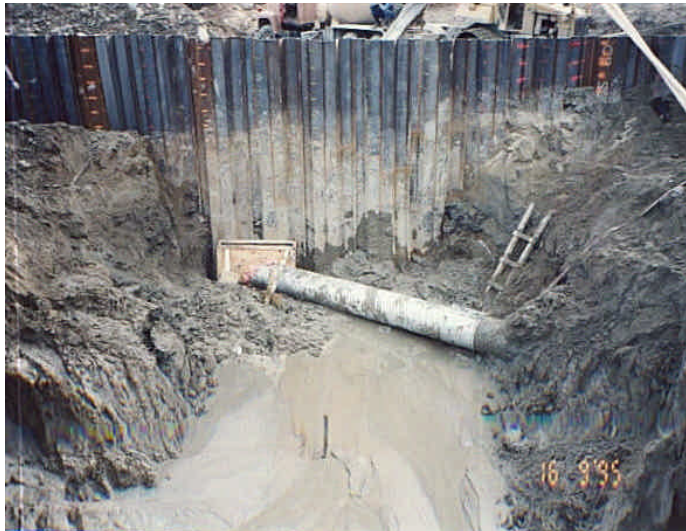
**Figure 3, Culvert Penetration**

The specifications called for driving the pile into the fractured bedrock until refusal to aid in ensuring a seal at the bottom of the barrier. During operations a drainage culvert from the Highway was discovered. This unexpected obstacle required a penetration in the barrier. This was accomplished by excavating the barrier at the location of the culvert and torch cutting a hole in the barrier. The culvert was installed through the hole and a concrete bulkhead cast to seal the penetration. The completed bulkhead is shown in Figure 3.
